Preliminary Arborist Report

**Carolan Ave. and Rollins Rd.
Burlingame, CA**

**PREPARED BY:
HortScience, Inc.
325 Ray St.
Pleasanton, CA 94566**

March 2014

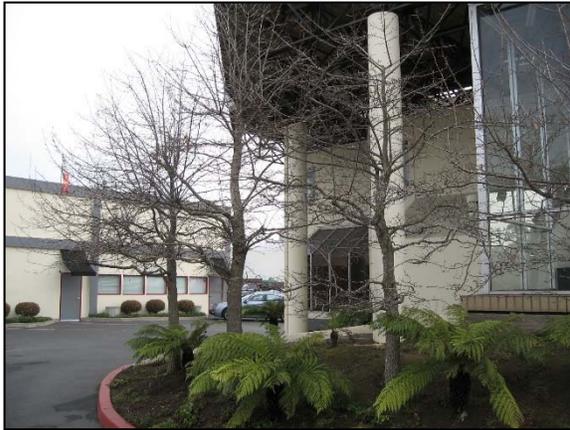
The most common on site species is hackberry with six (6) individuals (21% of population). The hackberries are all in fair condition and circle the back of the car dealership’s front office near Carolan Avenue (Photo 1, following page). All the hackberries had been topped and are one sided away from the building. They are young trees with diameters ranging from 6” to 11”.

Photo 1 – Young hackberries (#20-22) line the back of the auto showroom.

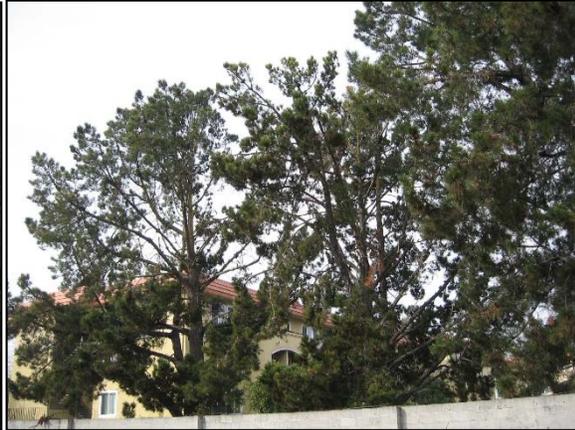
Four Monterey pines are growing off-site near the western property boundary (Photo 2, following page). These trees range from good (tree #12) to poor (trees #11 and 13) condition with one tree in fair condition (#14). All four trees have pine pitch canker resulting in varying levels of branch dieback and sap flow along trunks and branches. The Monterey pine trees are mature with diameters ranging from 20” to 24”.

Photo 2 – Mature Monterey pines (#13-14) are just off-site to the north of the property.

1. I recommend SummerHill Apartment Communities approach the adjacent property owner(s) and offer to remove declining trees #11 and 13-16.
2. Have the vertical and horizontal locations of all off-site trees that will be in close proximity to grading/utilities, etc. established and plotted on all plans. Forward these plans to the Consulting Arborist for review, an assessment of impacts and comment.

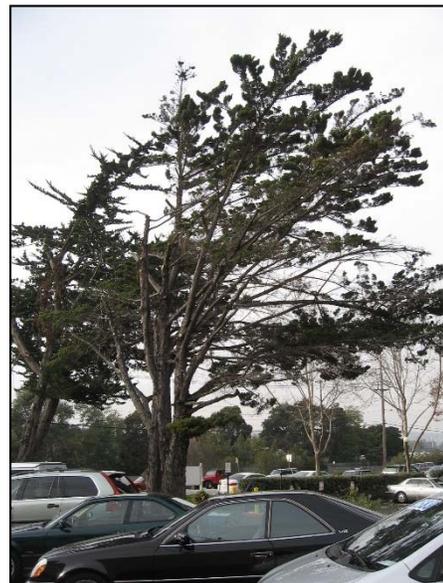
Three species (Monterey cypress, Australian brush cherry, and sweetgum) are represented by three (3) trees each. The Monterey cypress are mature and the largest trees assessed (Photo 3). All cypresses are growing off-site and range from good (#10) to poor condition (#15 and 16).

Photo 3 (above) – Monterey cypresses # 15 & 16 have been pruned hard and were declining.

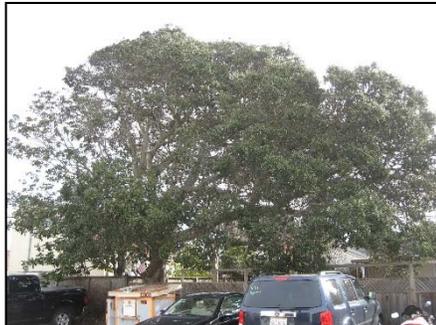
Two species (coast live oak and African fern pine) are represented by two (2) trees each. Both coast live oaks (#5 and 7) are growing off-site along the eastern fence line (Photo 4). Coast live oak #5 is semi-mature and in good condition, and #7 is mature and in fair condition. Two small African fern pines were planted in the landscape around the building closest to Rollins Rd. and both have been pruned into hedges.

Photo 4 (below) – Coast live oak #7 is growing on the property line and is one-sided south.
