**Revised Initial Study and Mitigated Negative Declaration
Residential Condominiums at 1509 El Camino Real
City of Burlingame, San Mateo County, California**

APPENDICES

Prepared for:
City of Burlingame

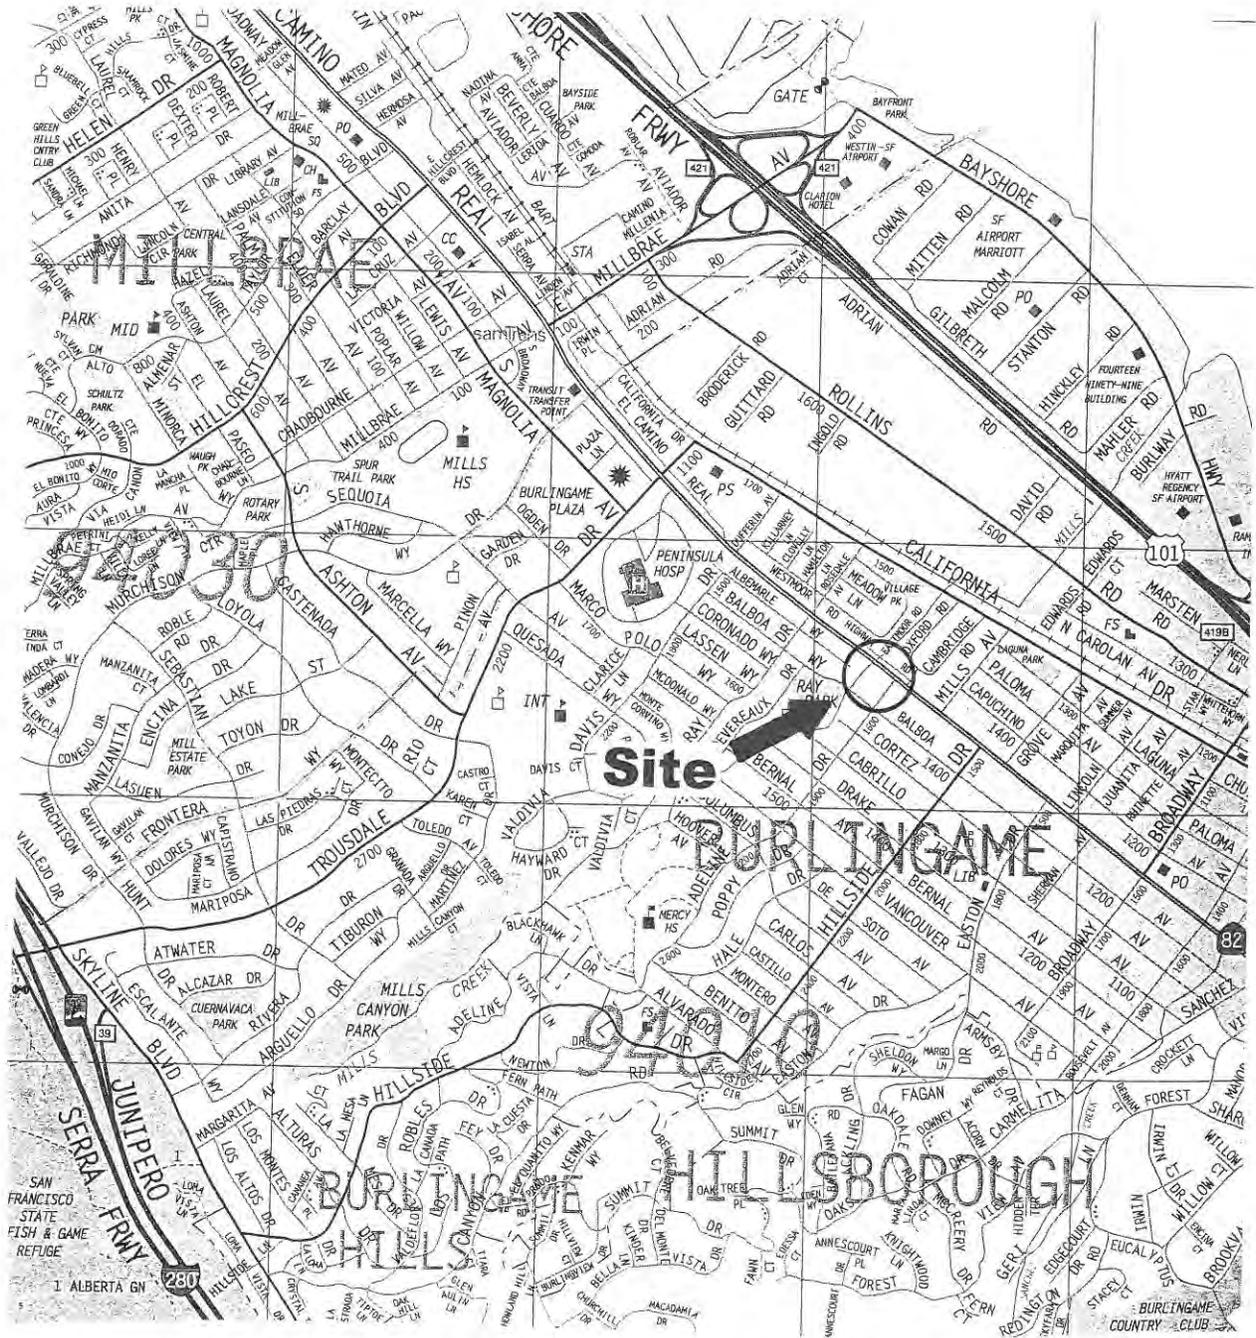
Figure 1 - Site Location

Source: Thomas Bros. Guide

The subject site is a gently sloping, rectangularly-shaped parcel located on the south side of El Camino Real (at the approximate location shown on Figure 1). The property is bounded by light commercial office buildings to the east, a concrete lined creek to the west, developed single family residential lots west of the creek and to the south, and El Camino Real to the north.

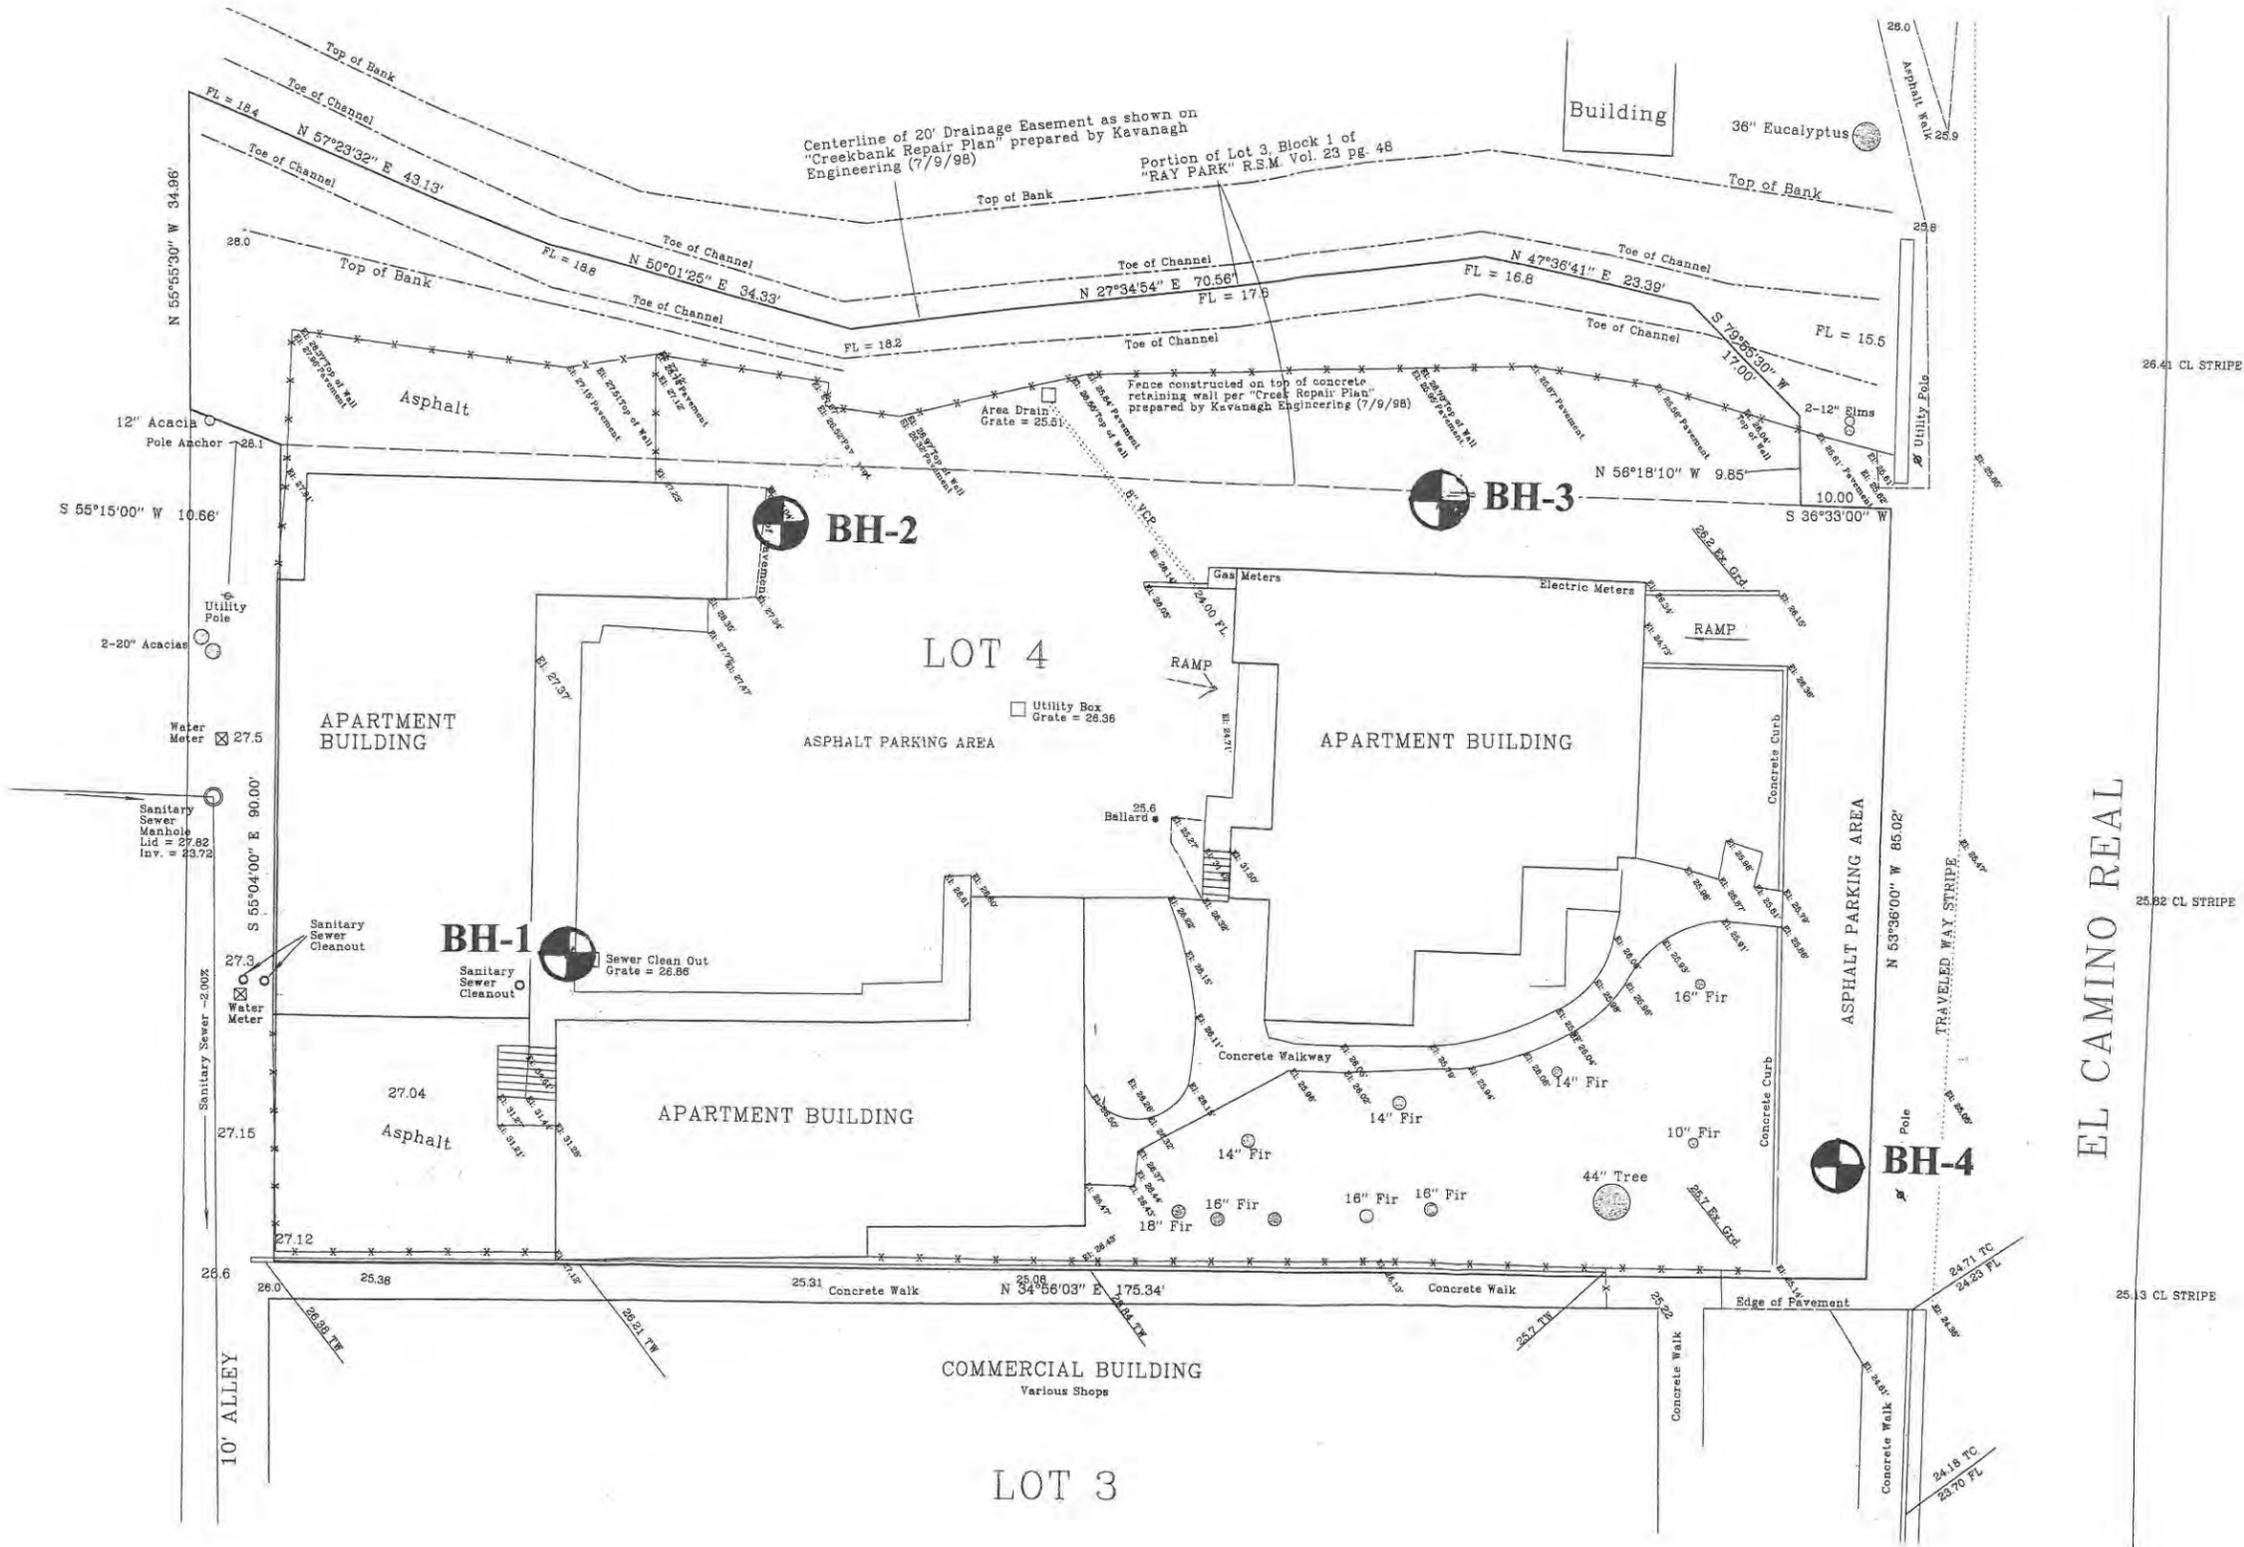
LOG OF BORING

DEPTH (ft)	SAMPLE NO.	SAMPLE LOC.	BLOW COUNTS <small>(12 inches)</small>	DESCRIPTION	DRY DENSITY <small>(pcf)</small>	MOISTURE CONTENT <small>(%)</small>
				2" ASPHALT over 2" BASEROCK silty CLAY - dark brown; slightly moist (CH)		
5	1 - 1		52	silty CLAY with some fine sand & some fine gravels - brown & red-brown; slightly moist; hard (CH)	-	-
10	1 - 2		83	fine sandy silty CLAY with fine gravels (subrounded to subangular) & small pockets of sand - olive-brown & green-brown; slightly moist; hard (CH)	111.9	18.2
	SPT			silty CLAY/clayey SILT - green-brown; slightly moist (CL-ML)		
15	1 - 3		58	silty fine gravelly SAND - light grey & rust-brown; slightly moist; very dense (SM)	-	18.4
20						
25						
30						
35						
				Groundwater encountered at 7 feet Bottom of boring at 14.5 feet Drilled on 02/27/07 Logged by ba Mobile B-24 drilling rig Modified California & Split Spoon samplers 140# hammer

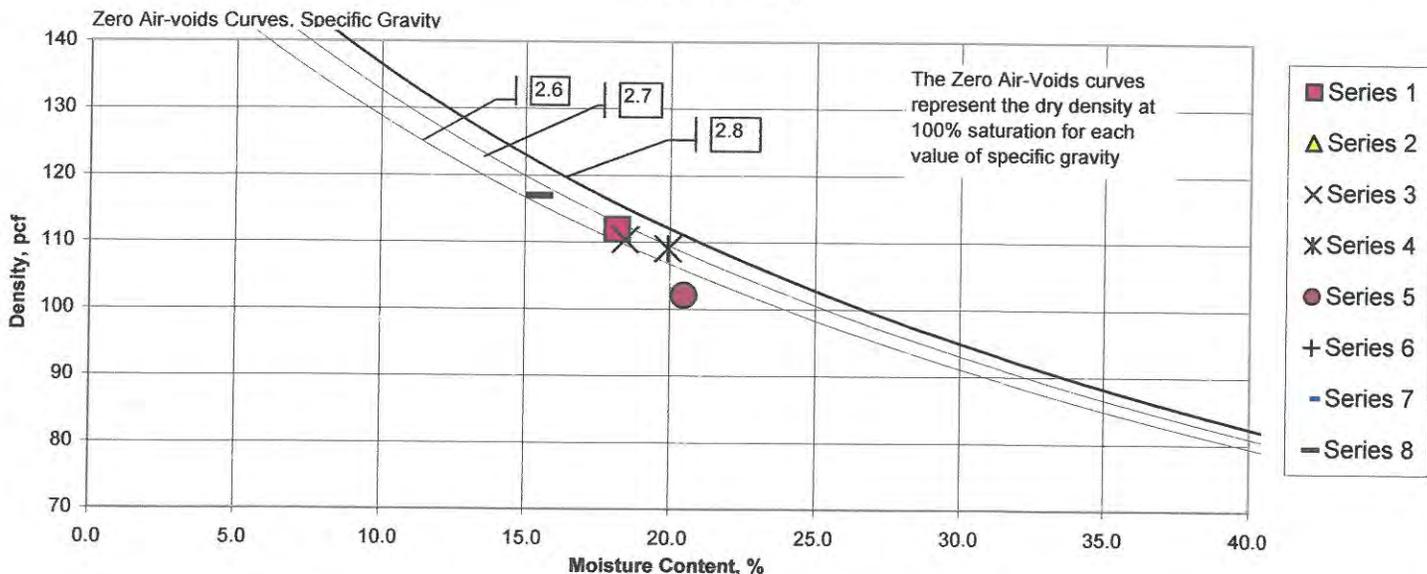
Moisture-Density-Porosity Report

Boring:	4-3							
Sample:								
Depth, ft:	11							
Visual Description:	Brown Clayey SAND							
Actual G_s								
Assumed G_s								
Total Vol cc								
Vol Solids, cc								
Vol Voids, cc								
Moisture, %	13.1							
Wet Unit wt, pcf								
Dry Unit wt, pcf								
Saturation, %								
Porosity, %								
Air filled Poros., %								
Water filled Poros., %								
Void Ratio								
Series	1	2	3	4	5	6	7	8

Note: If an assumed specific gravity (G_s) was used then the saturation, porosities, and void ratio should be considered approximate.

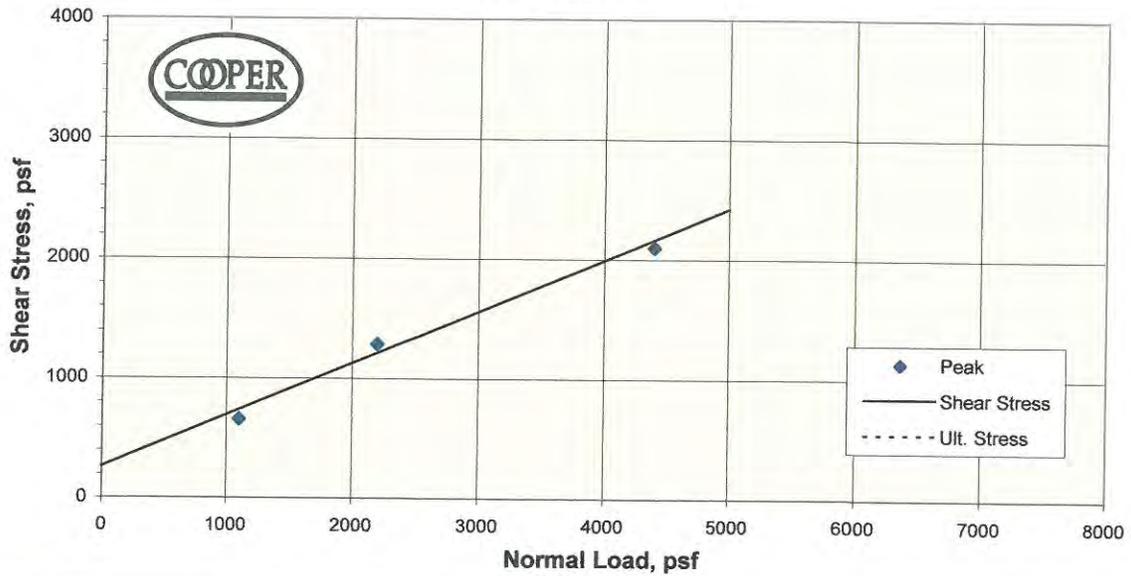
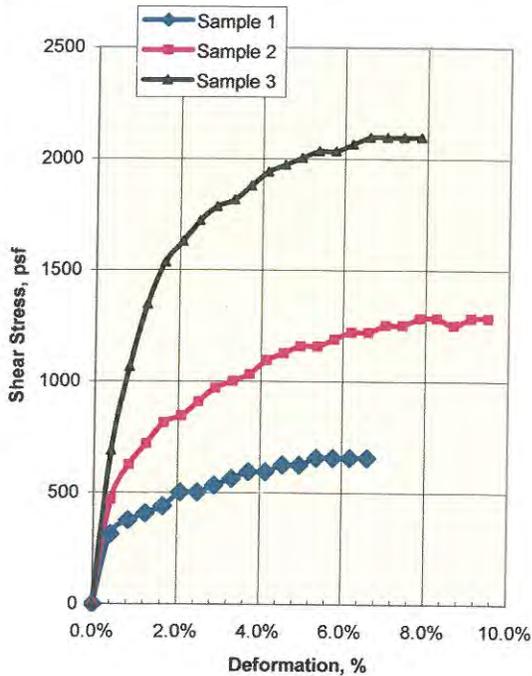
Direct Shear

ASTM D3080m

P. Phi (degrees)	23.4	Ult. Phi (degrees)	
P. Cohesion(psf)	260	Ult. Cohesion (psf)

Sample Data: Initial			
	1	2	3	4
Moisture %	22.5	22.5	22.8	
Dry Dens., pcf	92.4	94.0	95.0	
Void Ratio	0.824	0.793	0.774	
Saturation %	73.7	76.5	79.3	
Diameter	2.42	2.42	2.42	
Height	1.00	1.00	1.00	
	Sample Data: At Test			
	1	2	3	
Moisture %	25.4	23.9	22.6	
Dry Dens., pcf	94.8	99.1	103.4	
Void Ratio	0.778	0.701	0.631	
Saturation %	88.0	92.0	96.7	
Diameter	2.42	2.42	2.42	
Height	0.97	0.95	0.92	
Normal Stress, psf	1100	2200	4400	
Shear Stress, psf	657	1284	2098	
Strengths picked at	6.6%	9.5%	7.9%	
Ult. Stress, psf				
Strain Rate, in/min	0.020	0.020	0.020	
CTL #	060-1864			
Client:	GeoForensics			
Project	1509 El Camino - 207034			
Tested By:	MD			
Reduced By:	RU/MD			
Date:	3/14/07

Specimen #	Boring:	Sample:	Depth, ft:	Visual Soil Classification
1	4-1		1	Dark Gray Clayey SAND w/ Roots
2	4-1		1	Dark Gray Clayey SAND w/ Roots
3	4-1		1	Dark Gray Clayey SAND w/ Roots
4

Remarks: *DS-CU* A fully undrained condition may not be attained in this test.

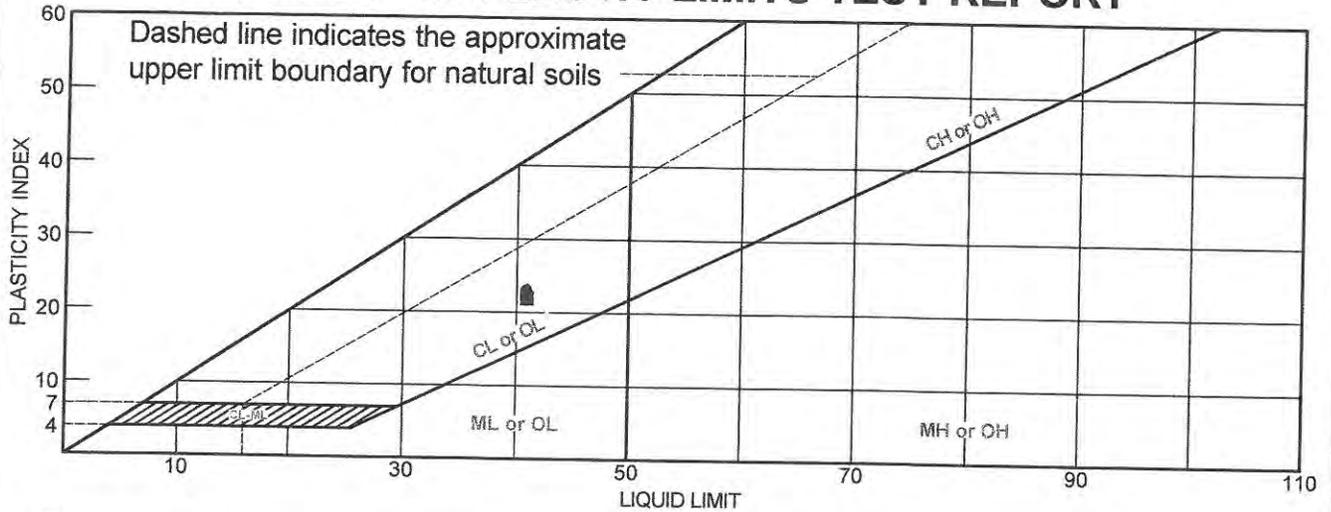
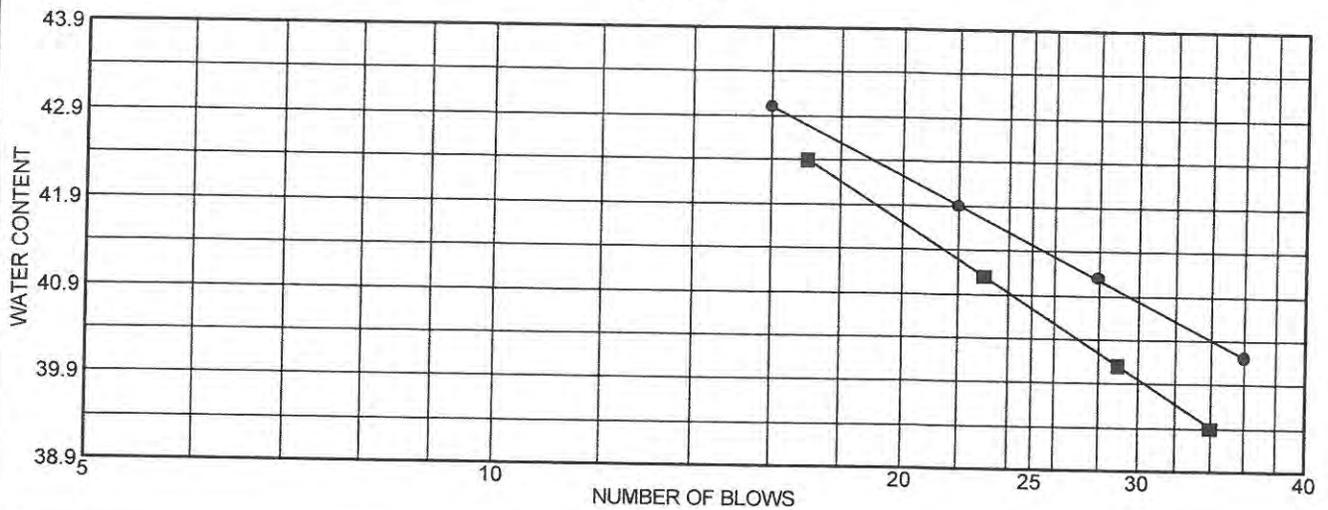
LIQUID AND PLASTIC LIMITS TEST REPORT

MATERIAL DESCRIPTION	LL	PL	PI	%<#40	%<#200	USCS
●	Grayish Brown Sandy Lean CLAY	41	18	23			
■	Dark Brown Sandy Lean CLAY	41	19	22

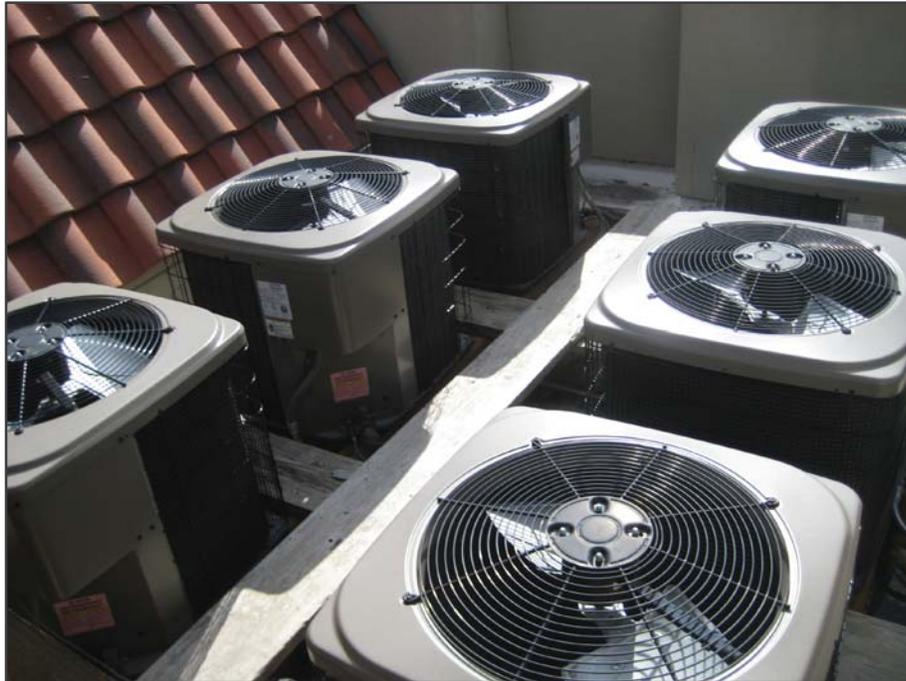
Photograph 1: Nine HVAC units on top of roof; located towards the front end of 1226 El Camino Real.

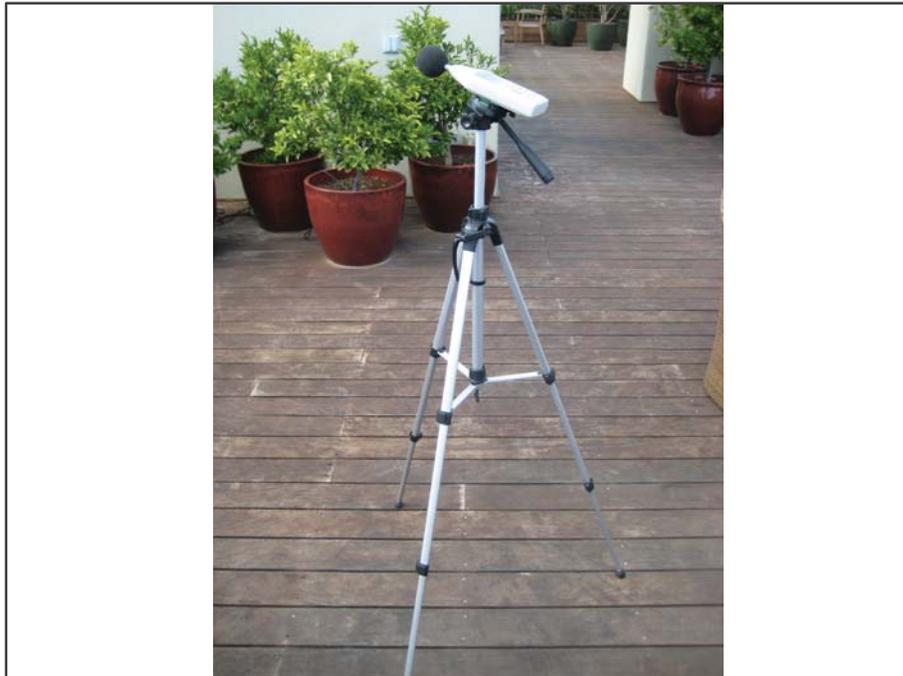
Photograph 2: Reading taken outside of HVAC units fenced in area, facing west.
